DEPARTMENT OF TRANSPORTATION**DIVISION OF ENGINEERING SERVICES**

Quality Assurance and Source Inspection

Contract #: 04-0120F4Cty: SF/ALA Rte: 80 PM: 13.2/13.9File #: 1.28**WELDING INSPECTION REPORT****Resident Engineer:** Pursell, Gary**Address:** 333 Burma Road**City:** Oakland, CA 94607**Report No:** WIR-015862**Date Inspected:** 29-Jul-2010**Project Name:** SAS Superstructure**OSM Arrival Time:** 700**Prime Contractor:** American Bridge/Fluor Enterprises, a JV**OSM Departure Time:** 1530**Contractor:** American Bridge/Fluor Enterprises, a JV**Location:** Jobsite**CWI Name:** See below**CWI Present:** Yes No**Inspected CWI report:** Yes No N/A**Rod Oven in Use:** Yes No N/A**Electrode to specification:** Yes No N/A**Weld Procedures Followed:** Yes No N/A**Qualified Welders:** Yes No N/A**Verified Joint Fit-up:** Yes No N/A**Approved Drawings:** Yes No N/A**Approved WPS:** Yes No N/A**Delayed / Cancelled:** Yes No N/A**Bridge No:** 34-0006**Component:** SAS OBG**Summary of Items Observed:**

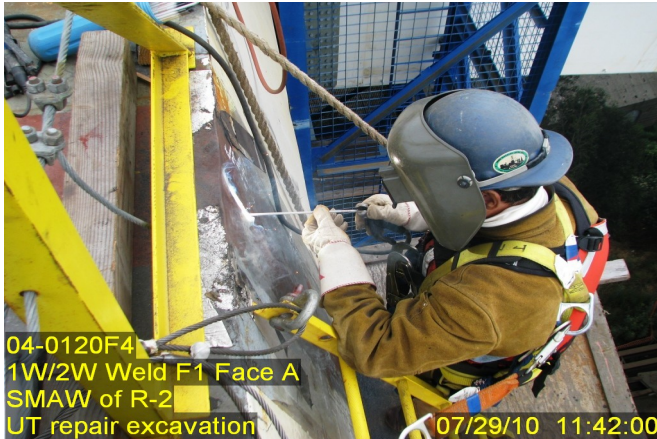
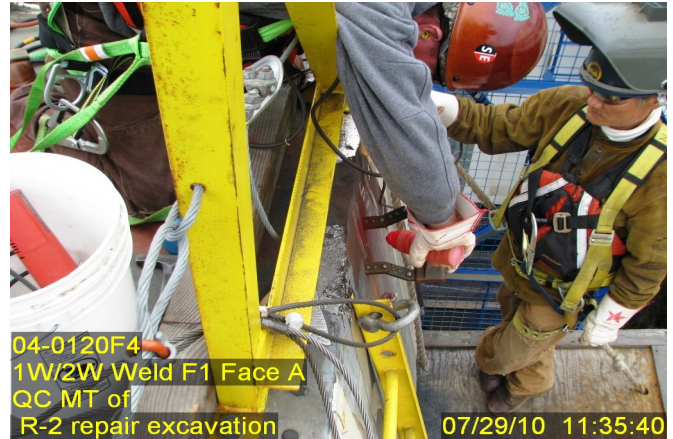
The QAI periodically observed AB/F approved welder Fred Kaddu (ID 2188) performing repair welding per the Shielded Metal Arc Welding (SMAW) process in the 1G (flat) position of repair excavations at Ultrasonic Testing (UT) reject areas from the A face. AB/F approved welder Kenneth Chappell was performing the excavating by grinding. AB/F QC Inspector Tom Pasqualone was present to monitor the progress and verify that the welding parameters were within the limits established by the approved welding Procedure Specification (WPS) identified as ABF-WPS-D1.5-1000-Repair. The QAI periodically observed QC Inspector Tom Pasqualone performing Magnetic Particle Testing (MT) of the repair excavations at the the repair locations prior to Mr. Kaddu performing welding. The QAI observed that the performance and evaluation of the MT appeared to comply with the MT procedure identified as SE-MT-CT-D1.5-101 Rev. 4. Work was not completed at this location during the QA Inspectors shift and the work appeared to be in general compliance with contract documents.

The QAI periodically observed AB/F approved welder James Zhen (ID 6001) grinding to excavate (1) one UT reject repair area on the A face of the OBG Field Splice 1W/2W Weld ID: F1. The QAI periodically observed QC Inspector Steve McConnell performing Magnetic Particle Testing (MT) of the excavation at the repair location to confirm the complete removal of the rejectable indication. The QAI observed that Mr. McConnell performed MT after Mr. Zhen indicated that he had observed a “line” when the depth of the excavation was approximately 10mm. Mr. McConnell performed MT and directed Mr. Zhen to perform additional grinding. Mr. Zhen began to grind and indicated that he observed porosity and then performed additional grinding and stated that it was removed. Mr. McConnell performed MT once again and stated that the gouge was clean. See photo below. The depth of the excavation was then approximately 15mm to 16mm. The QAI noted that the original indication rejected during UT from the B face was reported as 10mm deep. The QAI periodically observed AB/F approved welder James Zhen (ID 6001) performing repair welding of the excavated area per the Shielded Metal Arc Welding (SMAW) process in the 3G (vertical) position. See photo below. QC Inspector Steve McConnell was present to monitor the progress and verify that the welding parameters were within the limits established by the approved welding Procedure Specification (WPS) identified as ABF-WPS-D1.5-1000- Repair. The repair welding was not completed during the QA Inspectors shift and the work at this location appeared to be in general compliance with contract documents. See Summary of Conversation.

The QAI periodically observed AB/F approved welder James Zhen (ID 6001) performing repair welding of excavated areas per the Shielded Metal Arc Welding (SMAW) process in the 3G (vertical) position. QC Inspector Steve McConnell was present to monitor the progress and verify that the welding parameters were within the limits established by the approved welding Procedure Specification (WPS) identified as ABF-WPS-D1.5-1000-Repair. The repair welding was completed and the work at this location appeared to be in general compliance with contract documents.
